Use Attainability Analysis
Bucktail Creek
Lemhi County Idaho

Idaho Department of Environmental Quality

February 2002

Use Attainability Analyses
Bucktail Creek
Lemhi County Idaho

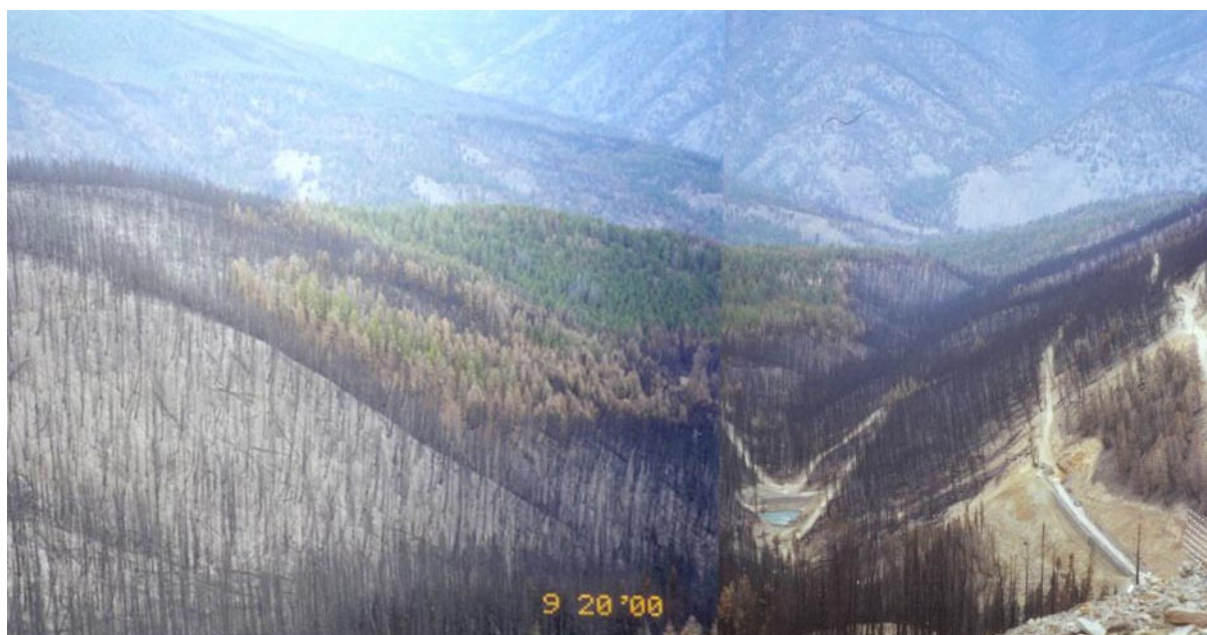
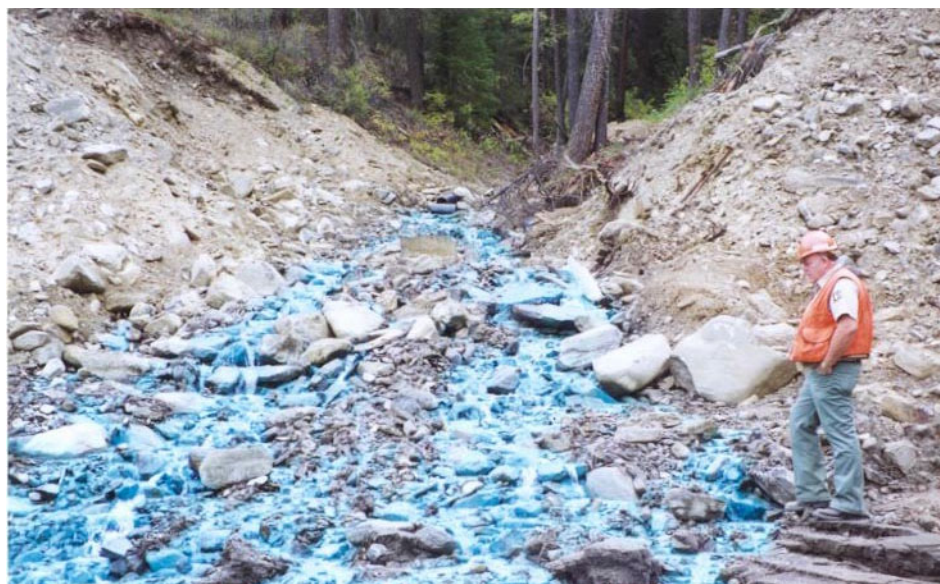
Cover photos – View from the waste rock dumps from the former Blackbird open pit mine at the headwaters of Bucktail Creek, downstream into the South Fork Big Deer Creek and Big Deer Creek drainages (top)

Lower Bucktail Creek following CERCLA “Early Action” remedial activities. Compare with *National Geographic* photo of baseline conditions in the Appendix 1.

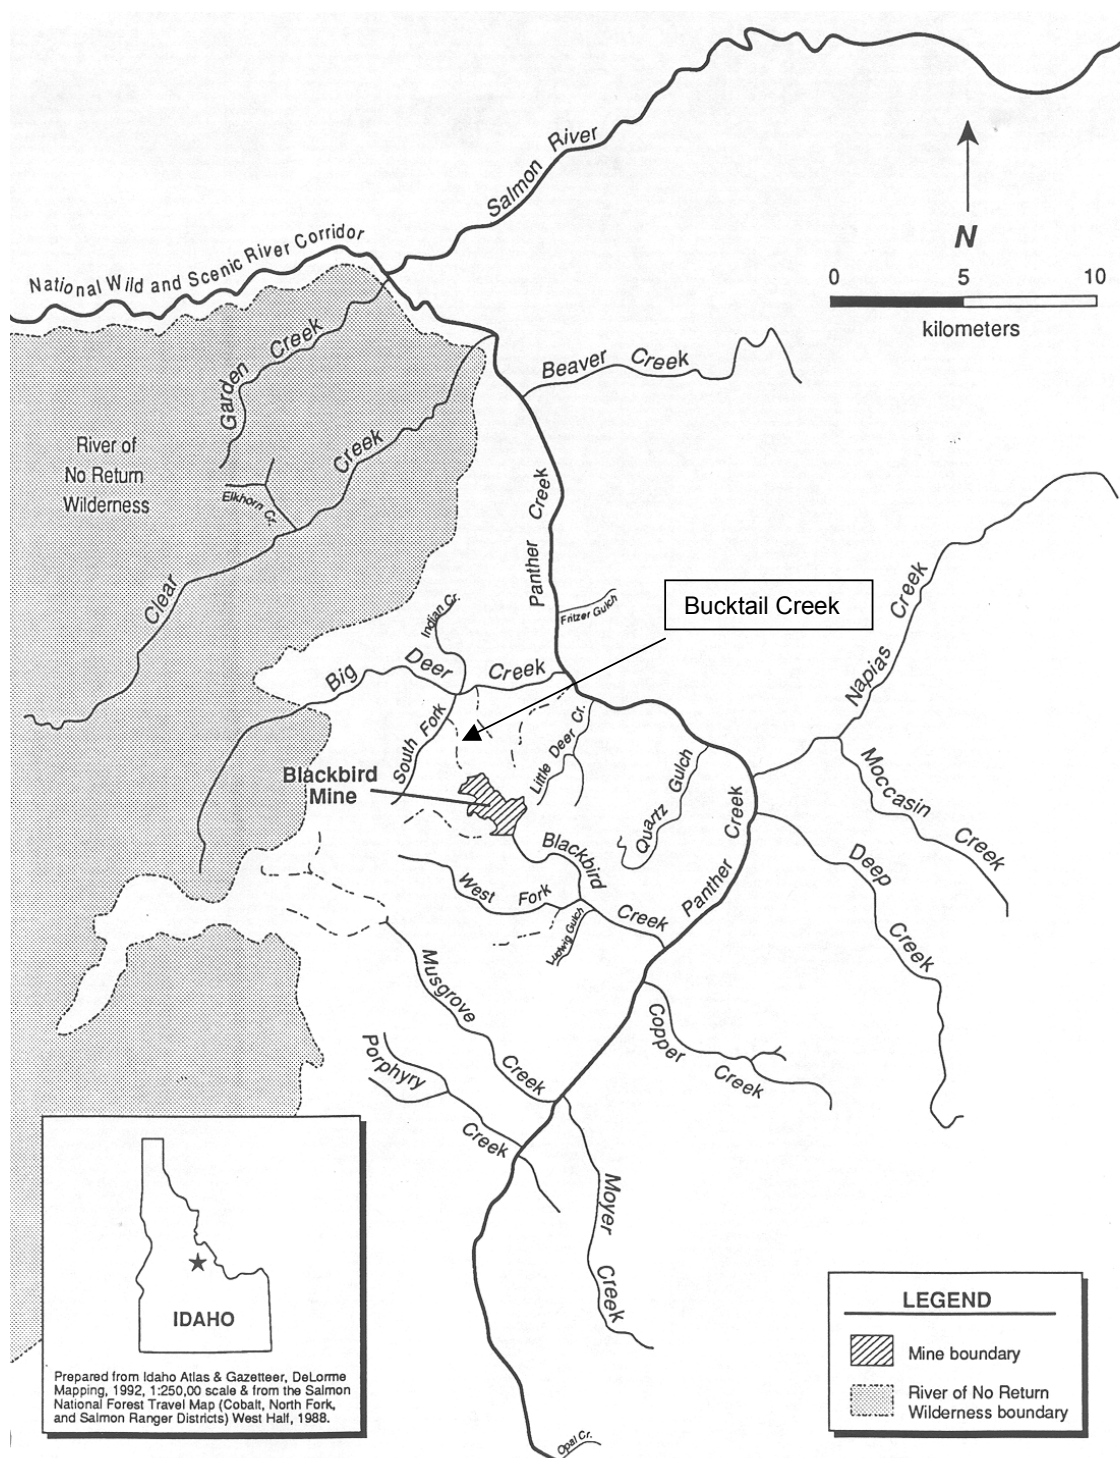
Figure 1. Blackbird Mine site vicinity and Bucktail Creek.

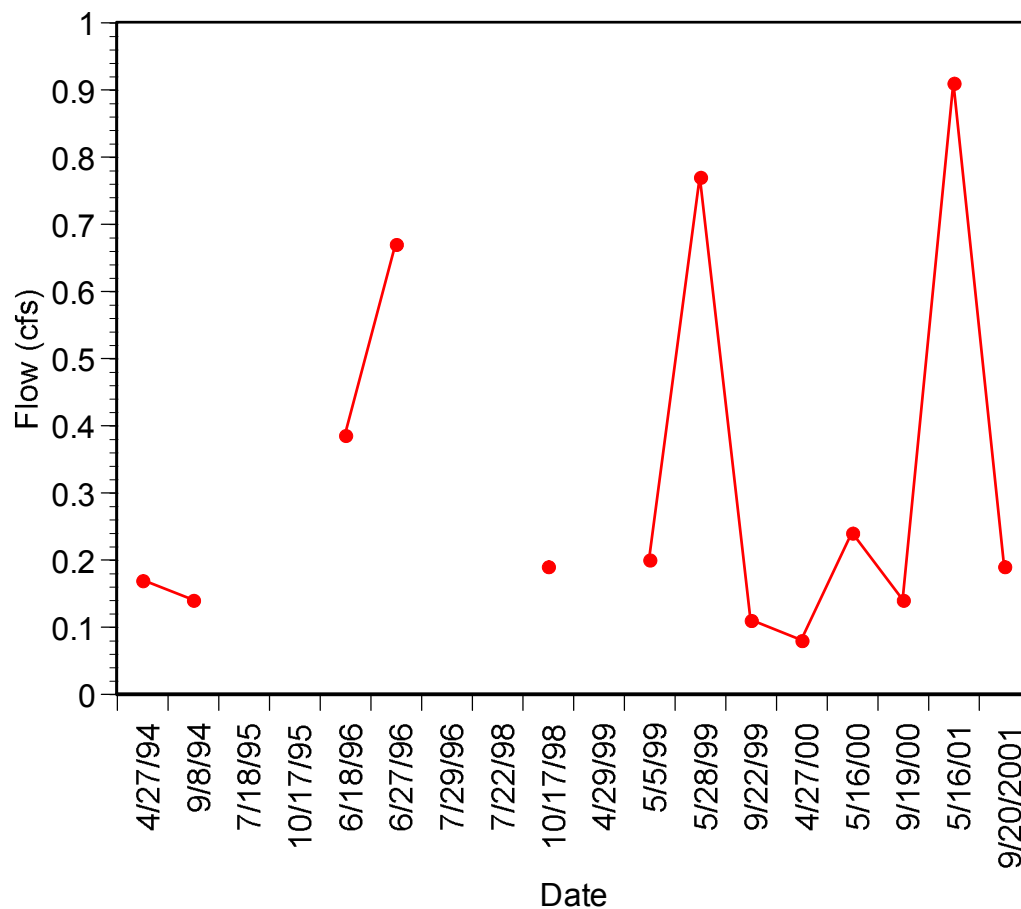
Figure 3. Measured flows in Bucktail Creek from 1994-2000. Data from RMC (1994) and the Blackbird Mine Site Group database, accessed June 2001, and Golder 2002.

For purposes of applying aquatic life standards to intermittent streams, water quality standards apply to intermittent streams only when flows exceed 1.0 cfs (WQS § 070.07). Streams with flows less than 0.1 cfs may be considered intermittent (WQS § 003.51). These recent flow records suggest that at times very little volume of water would be present for aquatic life to live in. Available depths probably preclude fish populations from establishing. Fish obviously need a minimum depth to swim. Minimum depths for adult trout to move upstream are about 12 cm (Bjornn and Reiser 1991). Often stream depths would be insufficient for fish movement, thus, populations would be unlikely to occupy and persist in Bucktail Creek based on flow alone.

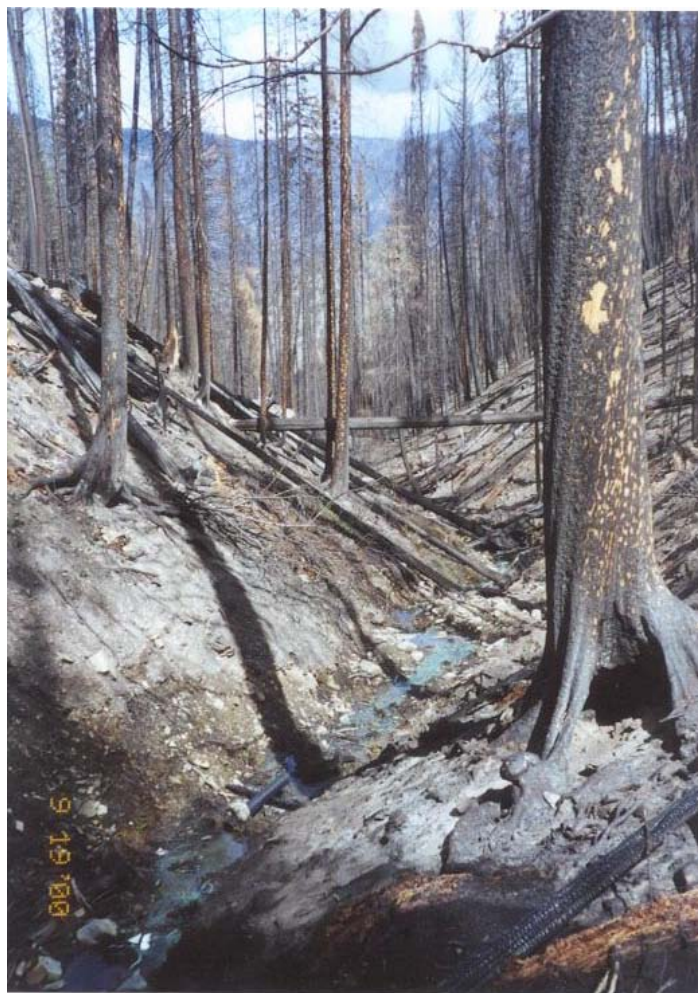
Mid Bucktail Creek, Post Clear Creek Fire Photo Taken 9-19-00 Flow is 40 gpm.

Figure 4. Top: Typical physical habitat conditions in the middle and lower Bucktail Creek drainage at typical base flow conditions (flow was 40 gpm, 0.09 cfs). The watershed had burned about 1 month before the photo was taken.

Bucktail Creek is a small, 1st order stream that averages an extremely steep gradient of 32%. Stream width generally ranges from <0.3 – 1 meter with depths of 5 – 15 cm. Measured flows have ranged from <0.1 cfs to 0.8 cfs (Figure 3). Two sediment control dams have been constructed on Bucktail Creek as part of the cleanup projects to reduce sediment transport downstream during construction of remedial projects. Figure 3 illustrates physical habitat conditions that are typical in the middle-and lower-reaches of Bucktail Creek.

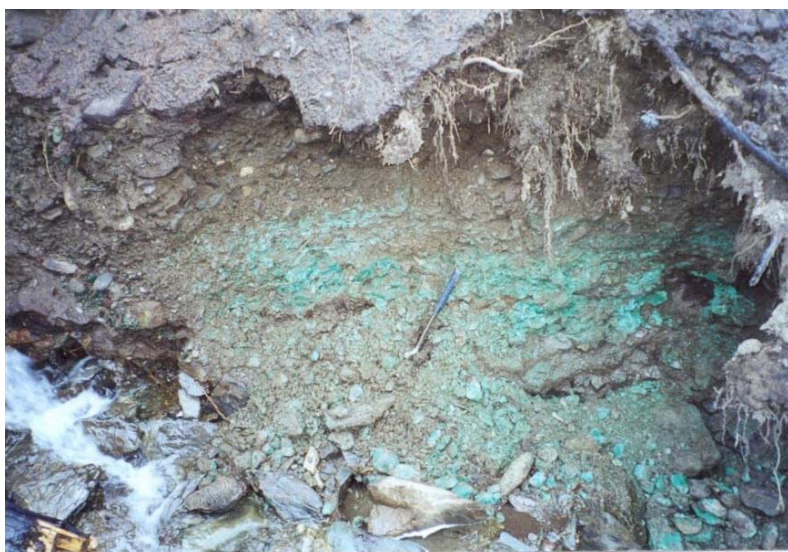
Bottom: Gravels in the streambed and banks of Bucktail Creek are visibly contaminated with copper.

Copper Carbonates in Gravels Along Lower Bucktail Creek. Note 16 inch Rock Hammer for Scale, 10-2000

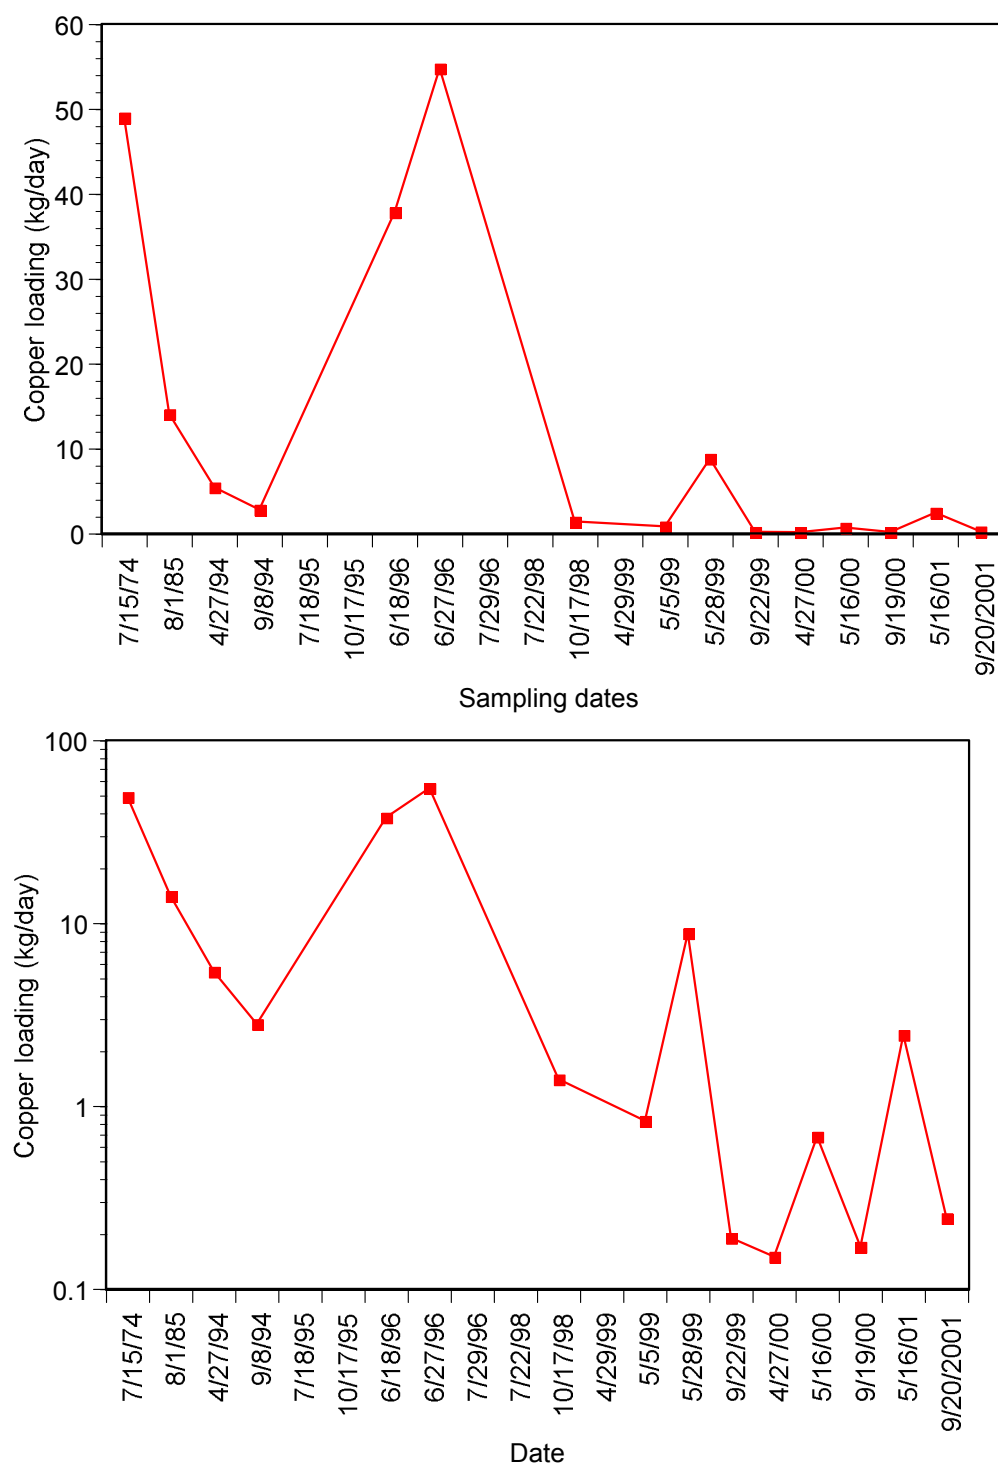
Figure 5. Bucktail Creek copper loads (kg/day) measured below major sources (referred to as the “upper road crossing” in most study reports). The graphs are identical except the lower graph is plotted on log scale to spread out the low load data points. Data from Baldwin (1978), Reiser (1986), RMC 1995, BMSG data base (accessed June 2001), and Golder 2002.

Copper loadings in Bucktail Creek below mine sources declined with natural attenuation from 1974 to 1994, then increased dramatically while cleanup construction was underway, and then were greatly reduced by 2001 (Figure 5). After completion of the Bucktail dam and diversion of collected waters through a tunnel in the mountain to the Blackbird water treatment plant in the fall of 1998, loadings in lower Bucktail Creek declined. By fall 2001, loadings were about 10% of loadings measured in 1994, prior to the recent cleanup activities.

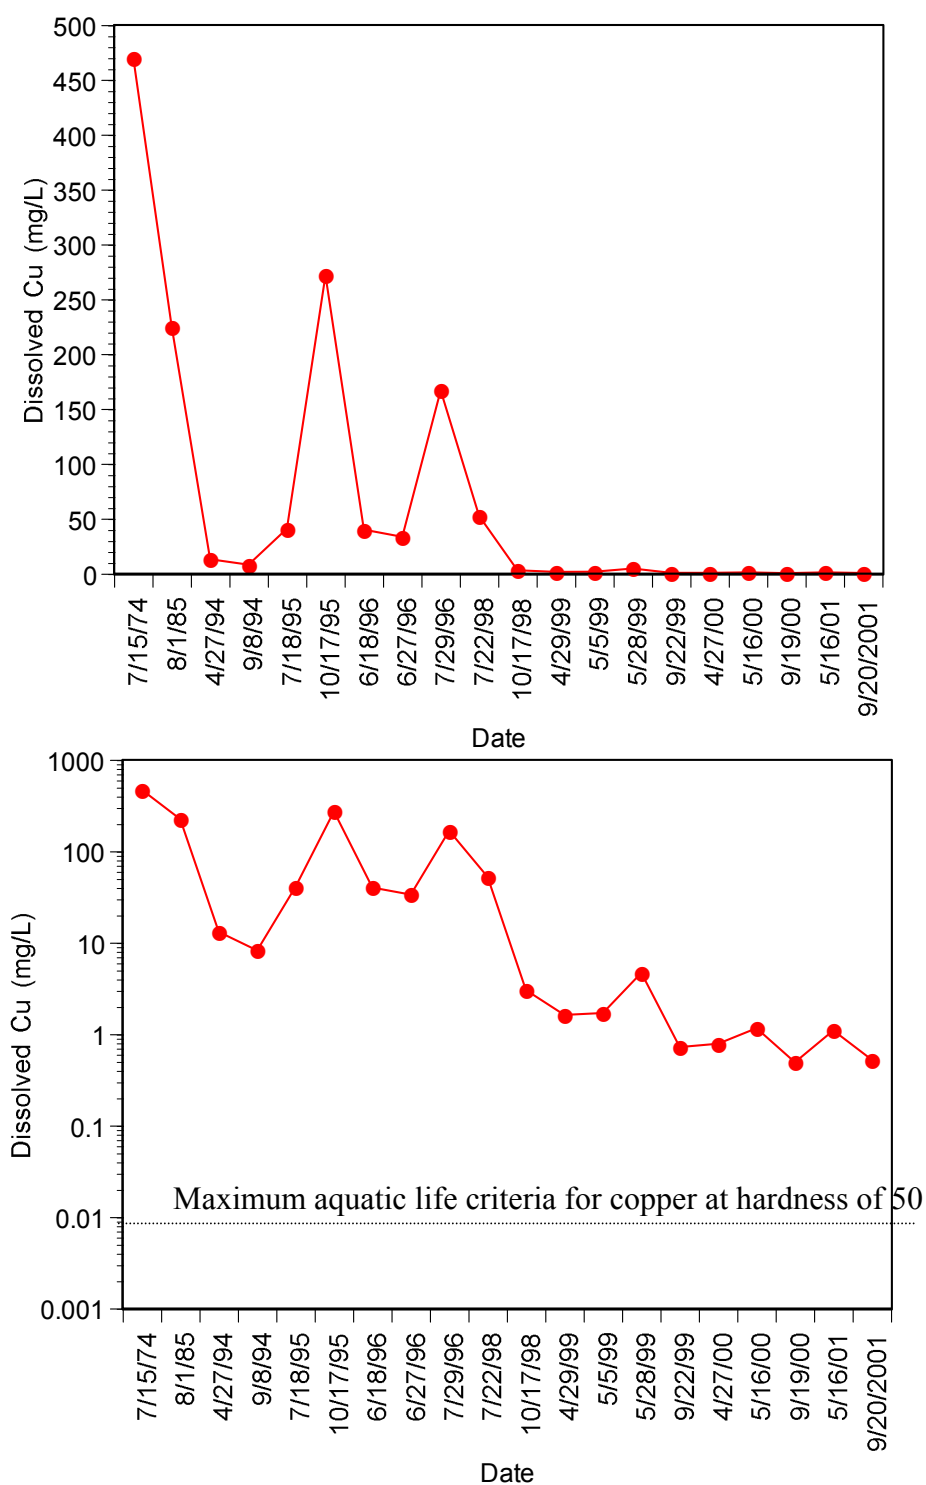
Figure 6. Bucktail Creek dissolved copper concentrations (mg/l) measured below major sources. The graphs are identical except the lower graph is plotted on log scale to spread out the low concentration data points. Data from Baldwin (1978), Reiser (1986), RMC (1995), the BMSG data base (accessed June 2001), and Golder (2002).

Copper concentrations in Bucktail Creek below the copper sources approached 500,000 µg/l in the mid-1970s, declining to around 10,000 µg/l by 1994 through natural attenuation. Concentrations increased dramatically during the construction disturbances around 1995-1996. These apparent disturbance caused increases were despite measures designed to reduce runoff from disturbed areas. The construction activities employed a variety of measures to limit short-

term disturbances such as erosion barriers on haul roads, and two sediment control dams which retained some water allowing settling during runoff. Since completion of major source reductions in the fall of 1998, copper concentrations appear to be stabilizing at about 500 µg/l (Figure 6). This is on the order of a 95% reduction in copper concentrations from 1994 to 2001 downstream of the dam and water treatment plant diversion. These recent conditions are greatly improved from historic conditions and may ultimately result in full recovery of Big Deer and Panther Creeks, the downstream receiving waters. However, even after about a 95% improvement dissolved copper concentrations are still about 40 to 70 times higher than the aquatic life criteria for copper.
